## Vanguard Applications Ware Software Release Notice

Release 6.1.R000

This notice contains update information for Release 6.1.R000 of the operating software for these Vanguard platforms:

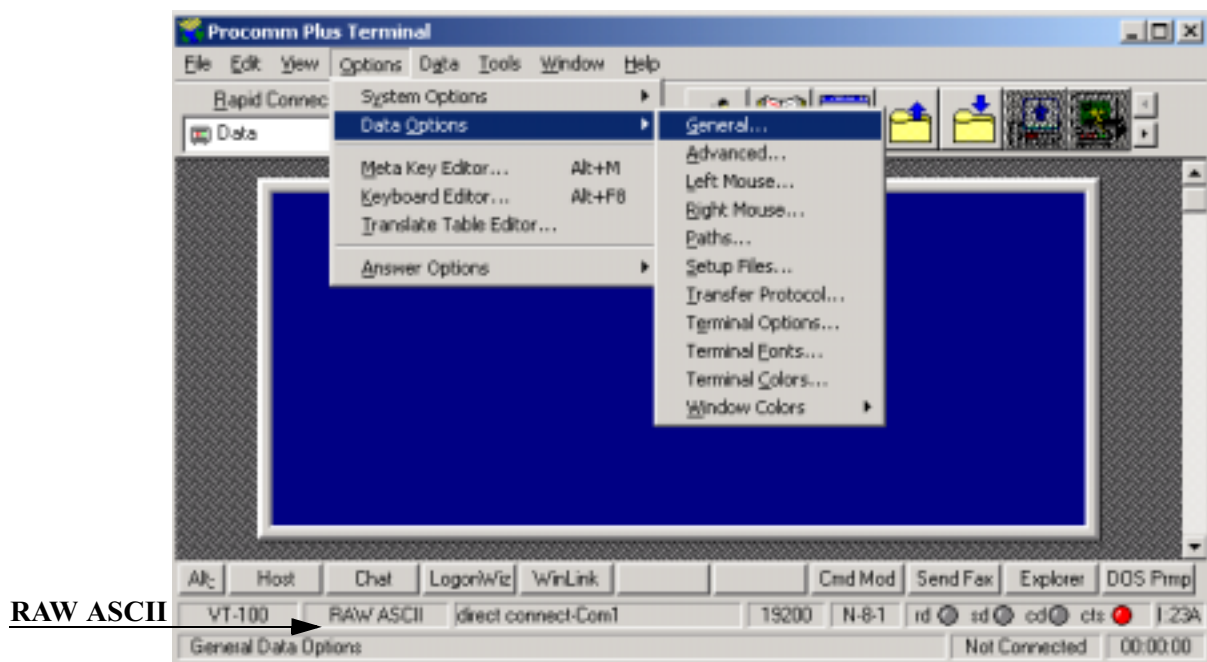
**Figure 4. Procomm Plus Terminal**

To be sure you are in RAW ASCII transfer mode, when in Procomm, check the setup file. **Options->Data Options**

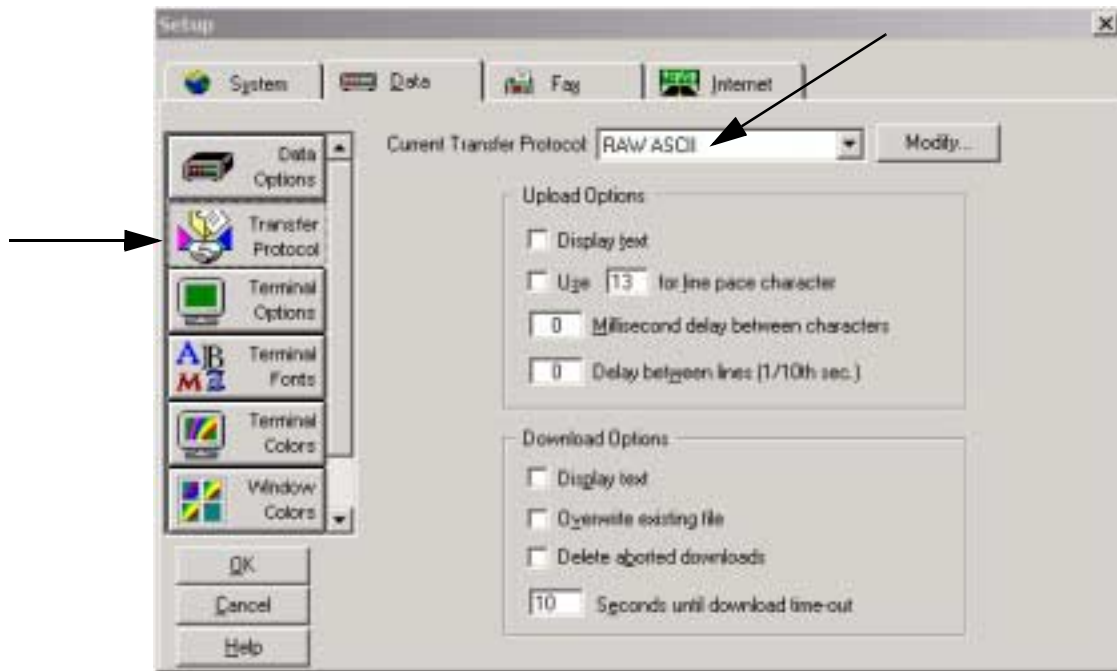
**Figure 5. Procomm Setup Menu**

When **Options->Data Options->Transfer Protocol** is selected, a Setup menu displays.

- Select RAW ASCII from the Current Transfer Protocol pull down menu
- Click the Transfer Protocols button

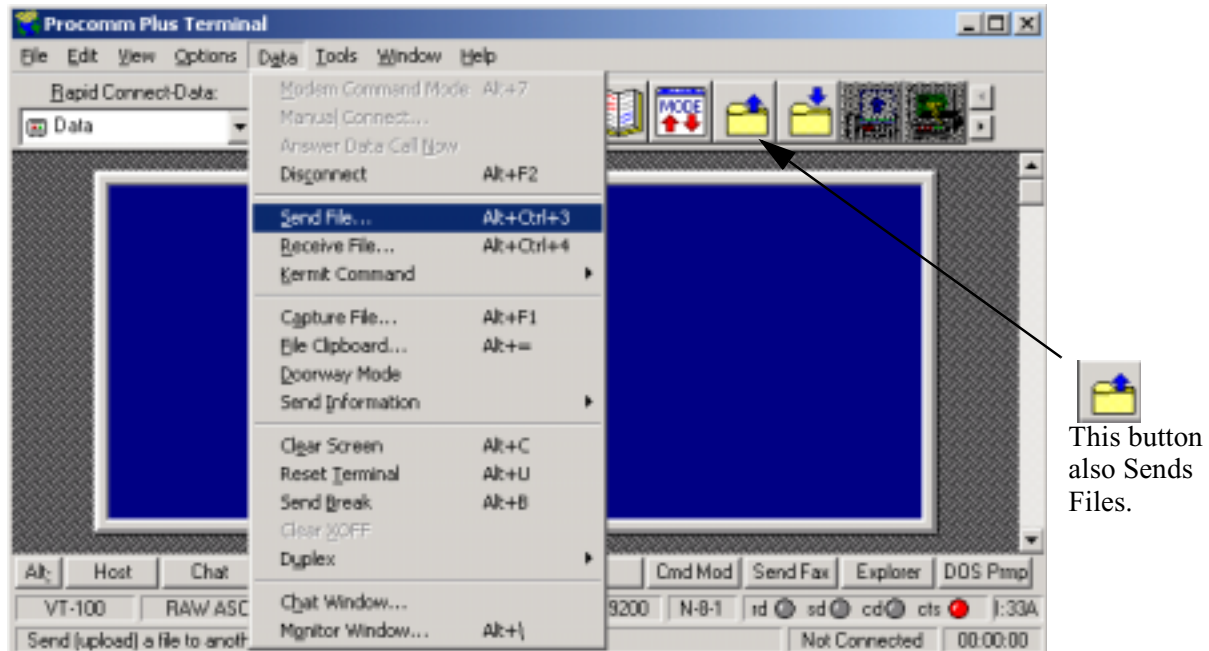
**Figure 6. Procomm Plus Terminal Send File**

To send a file, open the Procomm application. Under the **Data Menu** select **Send File**.

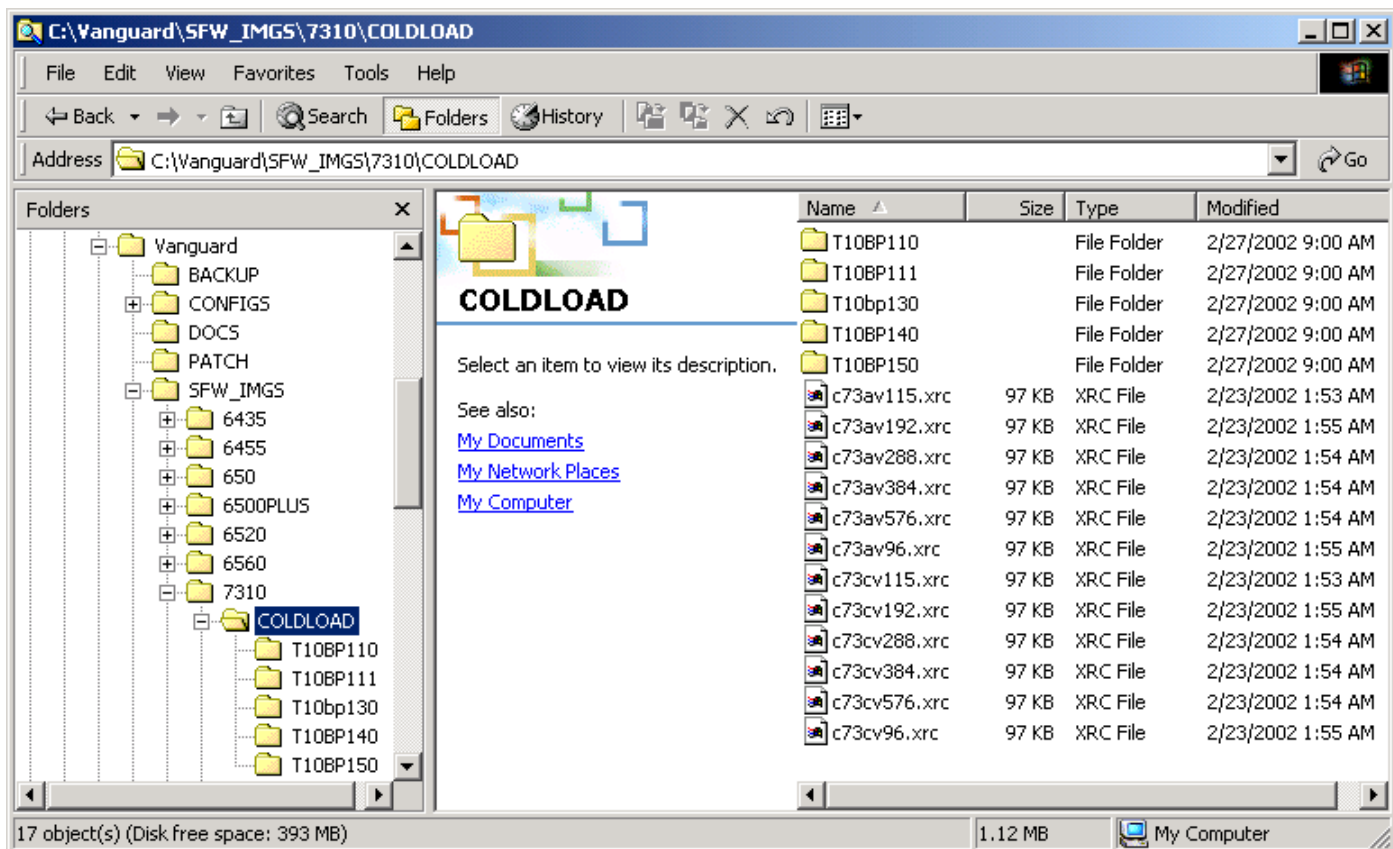
**Figure 7. COLDLOAD Directory**

**Directory Example** Figure 7 shows a Vanguard 7310 Directory selected.  
C:\Vanguard\SFW\_IMGS\7310\COLDLOAD

Under the SFW\_IMGS directory all the Vanguard products are listed. To select a Vanguard 6455 the path would be:  
C:\Vanguard\SFW\_IMGS\6455\COLDLOAD

Below is a step procedure on how to coldload the Bootprom using Procomm Communication software. This procedure example was documented using a Vanguard 7300 Series router. Figure 7 on page 31 shows the various product directories.

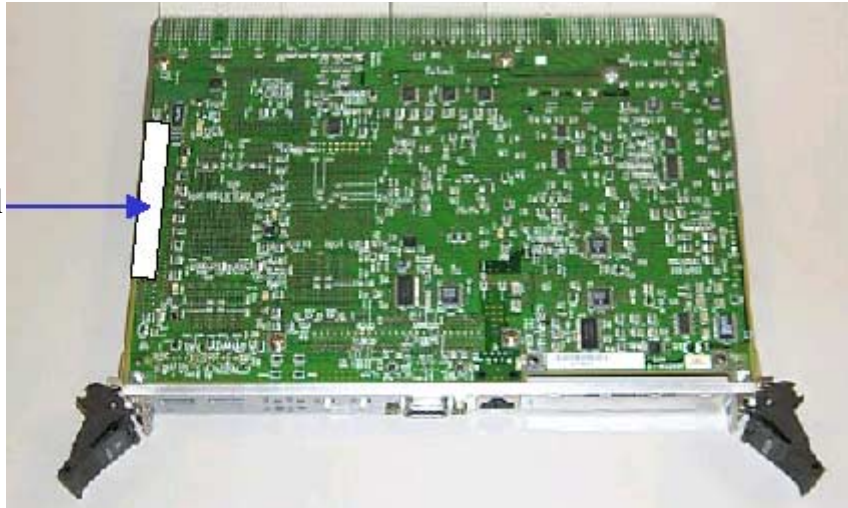
***Figure 8. Board Assembly Number Label***

Refer to Figure 8 to locate your board assembly number:

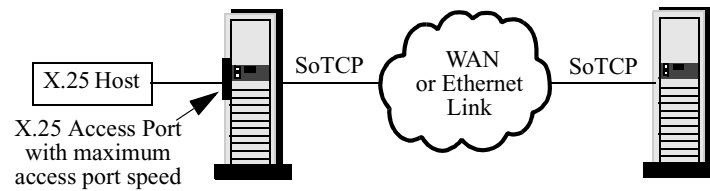
**Figure 12. Input Data Rate for SoTCP Sessions**

The input data rate is controlled by the port speed setting on the X.25 access port as shown in the figure:

The maximum access port speed that can be supported by SOTCP varies with the number of SoTCP sessions in place. These tables show the recommended maximum limit on access port speed for a given number of SoTCP sessions:
